AURIX™ TC37x errata sheet

Marking/Step: (E)ES-AA, AA

10525AERRA

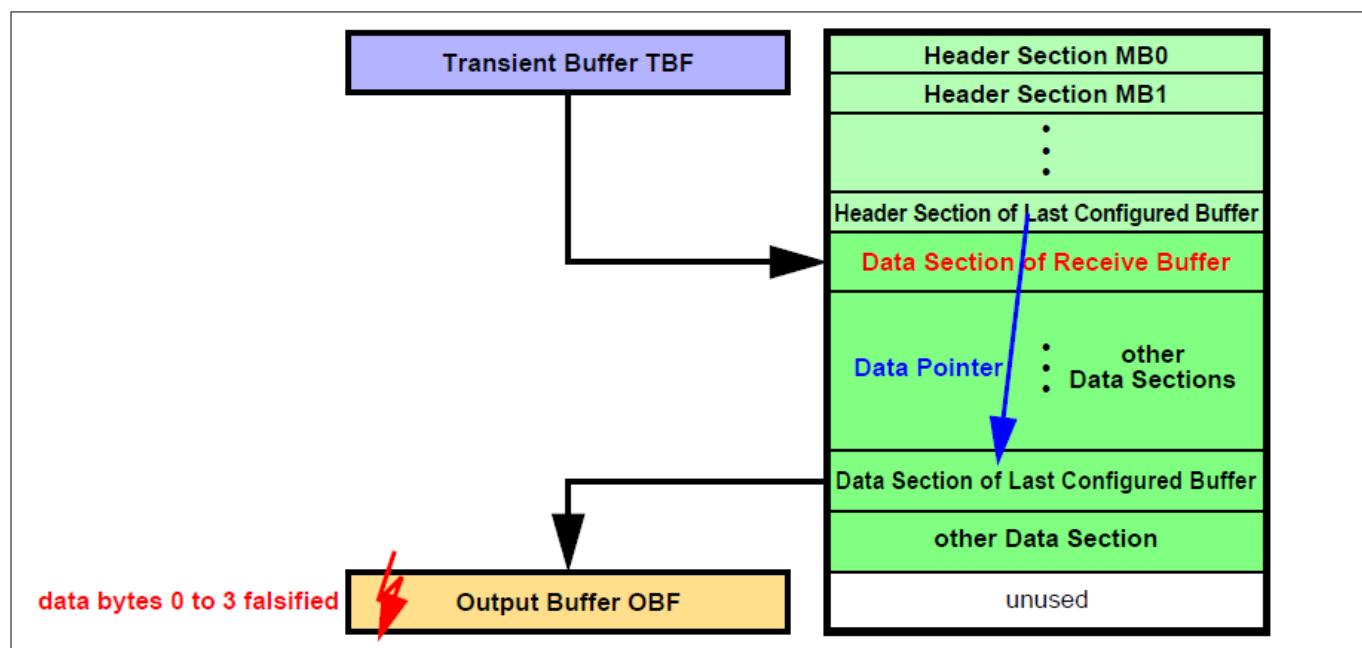
Figure 1 Message buffer transfer from Message RAM to OBF

When the message buffer has its payload configured to maximum length (PLC = 127), the OBF word on address 00h (payload data bytes 0 to 3) is overwritten with unexpected data at the end of the transfer.

Ensure that the Data Section directly following the Header Partition is assigned to a transmit buffer.

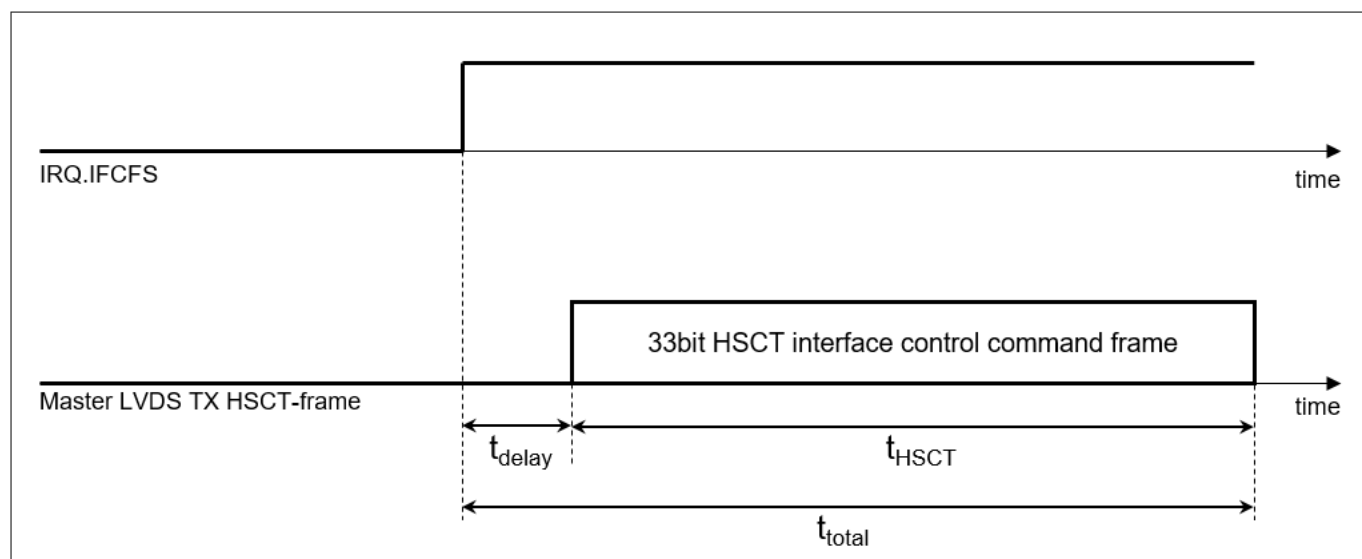
Figure 12 Timing of LVDS TX interface command sending in relation to IRQ.IFCFS

the user might falsely assume that also the actual sending on the LVDS TX port has already occurred once the IRQ.IFCFS flag is set, which is not true.

Instead the timing shown in the following figure applies.

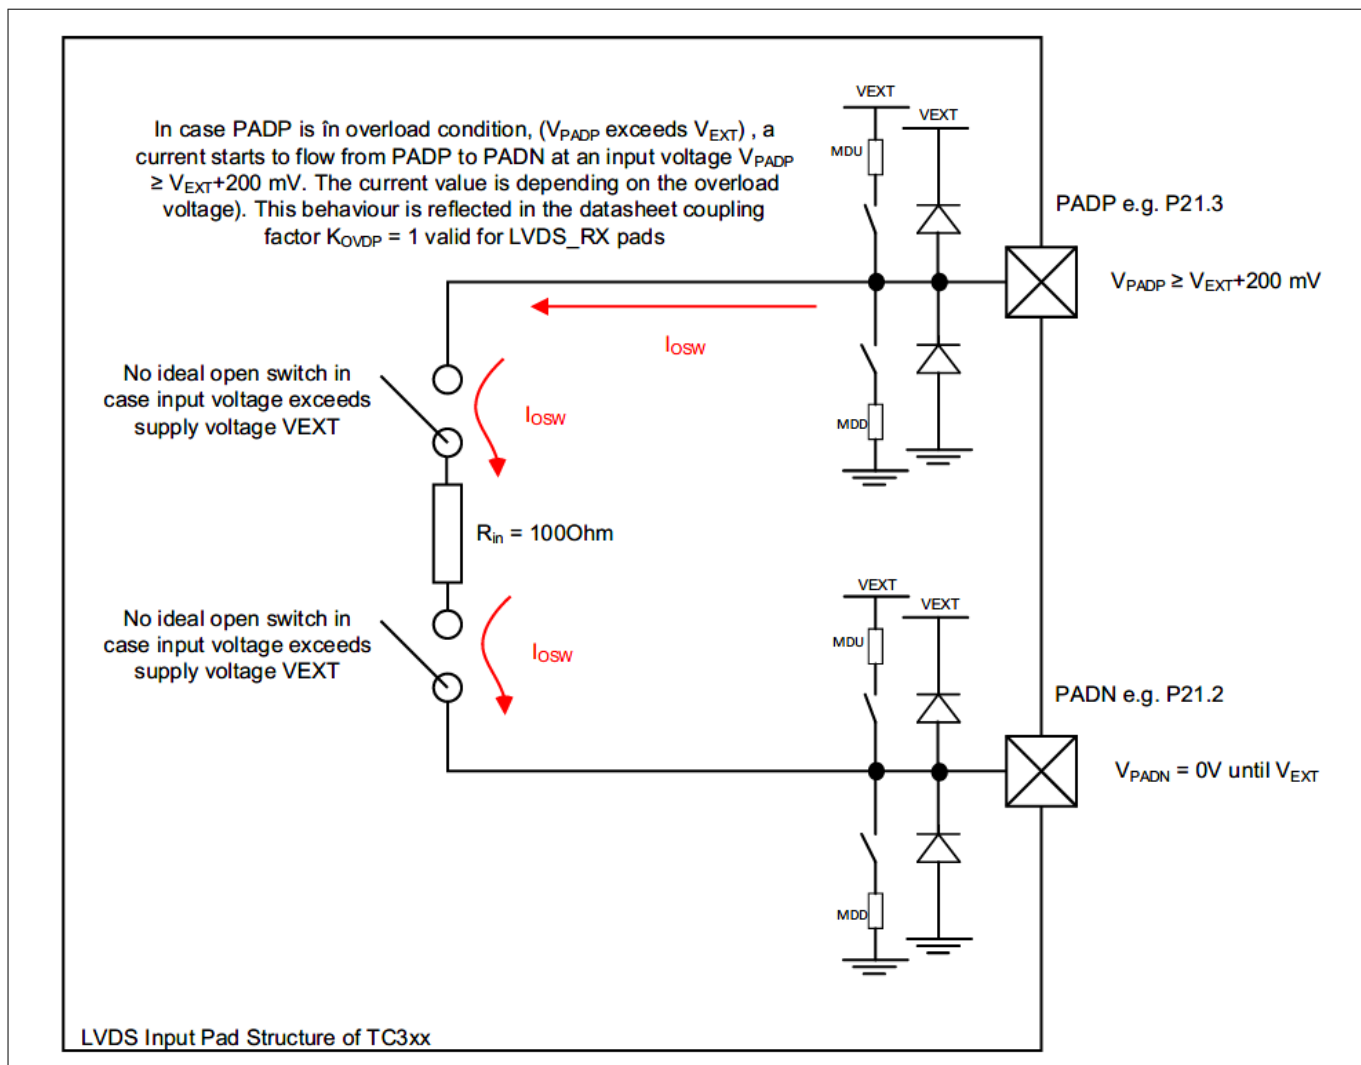
Figure 14 **Positive overload on P-pad of a LVDS RX pin pair (both used as inputs)**

Note: In general, the effect will also occur if the N-pad is used as output, or for a negative overload condition on either the P-pad or the N-pad.
