Intel® 80314 I/O Processor Companion Chip

Specification Update

| *July 2004*

Order Number: 273759-006

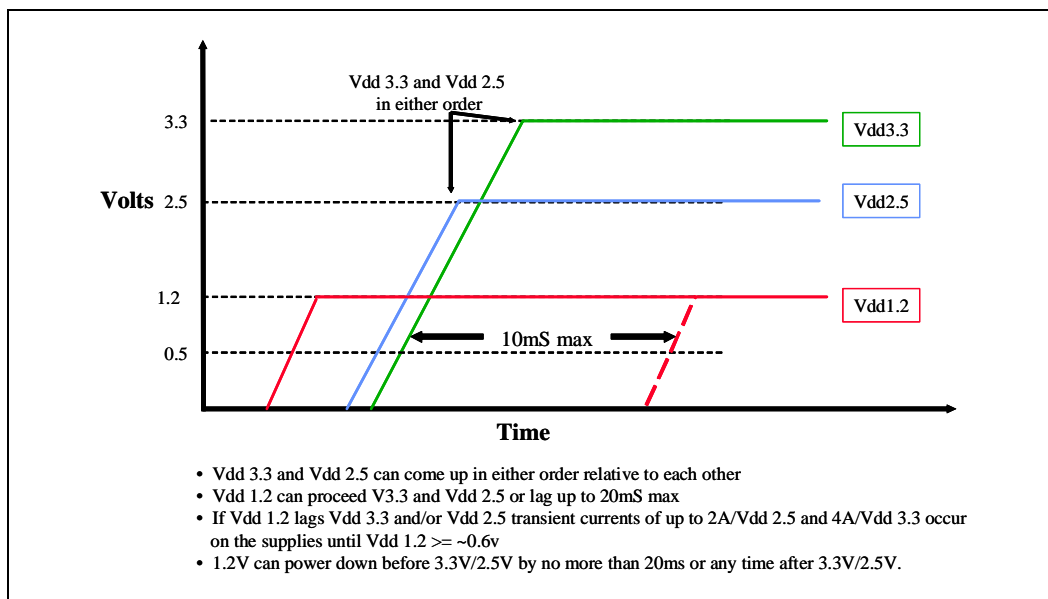
Figure 1. Power-Sequencing Requirements

Issue: The power-up and power-down sequences of the 80314 1.2 V/2.5 V/3.3 V supply rails has been revised from version 003 and 004 of this specification update. The power sequencing requirements initially presented in version 003 were designed to avoid transient current draw that could appear on the 2.5 V/3.3 V supply rails. Further investigation has determined that no current transients occur when the 1.2 V supply is ramped first. In addition, it is acceptable to ramp the 1.2 V supply after the 2.5 V and 3.3 V supplies as long as the lag is less than or equal to 20 mS. When the 1.2 V rail lags the 2.5 V and/or 3.3 V rail, transient currents of up to 2 A/V_{DD2.5} and 4 A/V_{DD3.3} can occur on the supplies until V_{DD1.2} >= ~0.6 V. The 1.2 V supply can power down no more than 20 ms before or any time after the 3.3 V/2.5 V supplies power down. These requirements are illustrated in Figure 1.
