82559 Fast Ethernet Multifunction PCI/CardBus Controller

Stepping Information

October 2004

Revision 2.2

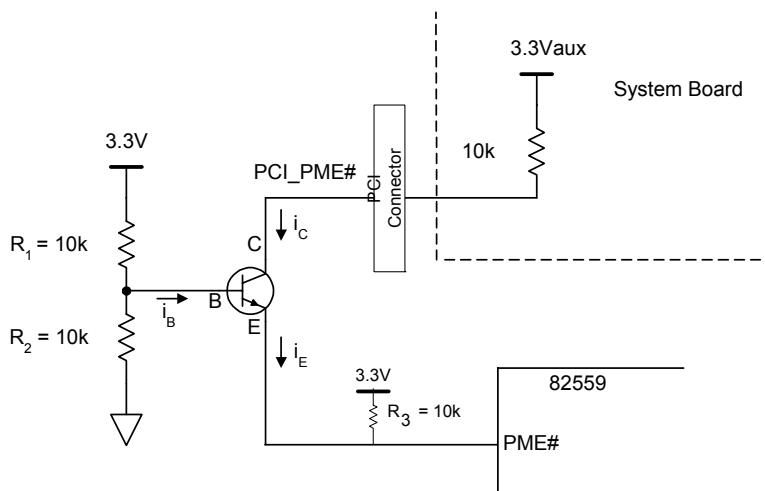
Problem: During power cycle events, the electrostatic discharge (ESD) elements internal to the 82559 may falsely clamp the Power Management Event (PME) output signal to approximately 1.5 volts for 100 ms to 150 ms during initial power up. This can cause wake-up events to be recognized by the system if power management events are enabled in the system chipset. This may result in a problem for mobile environments since the false clamping can cause a suspended system to wake up when the power to the LAN device is transitioned.

Implication: The implications of this anomaly depend on the target system configuration. In desktop and server systems, the impact is limited to a false wake-up event occurring when a new card is installed. In mobile systems where the LAN power is transitioned more frequently, the PME signal should be disabled during transitions.

Workaround: False PME indications can be avoided by disabling the recognition of a PME before removing or restoring power to the 82559. If a hardware solution is required, the following isolation circuit has been proven to be effective. The circuit requires the PCI PME signal (PCI_PME#) to be isolated from the 82559 PME signal (PME#). The system does not see the 1.5 voltage level drop caused by the 82559's power transition.
