# Intel<sup>®</sup> StrongARM<sup>\*</sup> SA-1110 Microprocessor

Specification Update

*April 2001*

Order Number: 278259-022

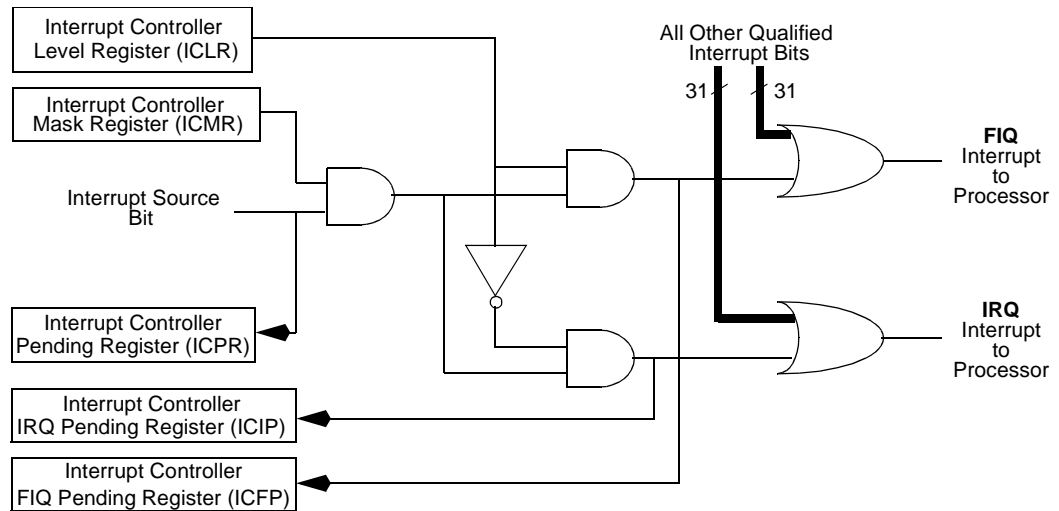
Figure 9-2. Interrupt Controller Block Diagram

Figure 9-2 now appears as:

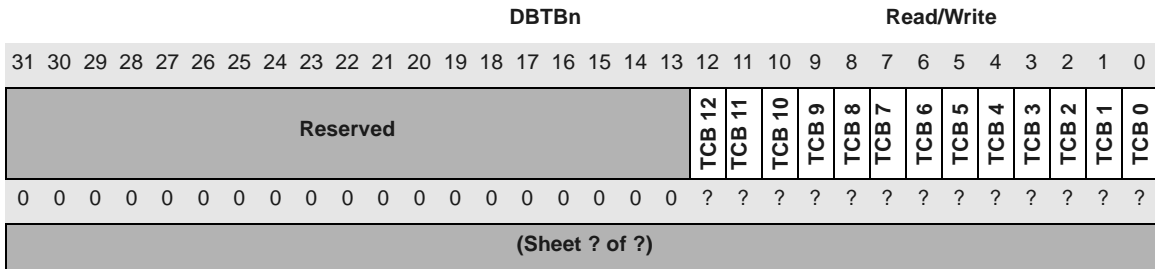
**58. DMA Buffer B Transfer Count Register (DBTBn): Section 11.6.1.6**

Changed DMA Buffer B Transfer Count register reset values for the Reserved bits to 0.

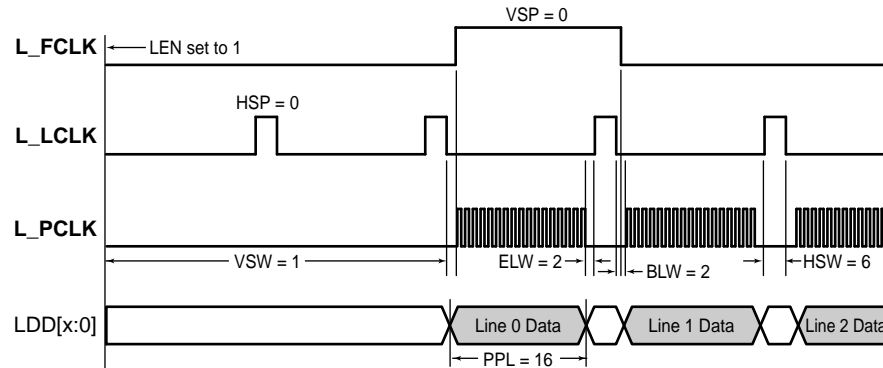
Figure 11-10. Passive Mode Beginning-of-Frame Timing

Changed the Notes: in Figure 11-10 to show the range of HSW as 1 to 64, not 0 to 64. The corrected figure is shown below:

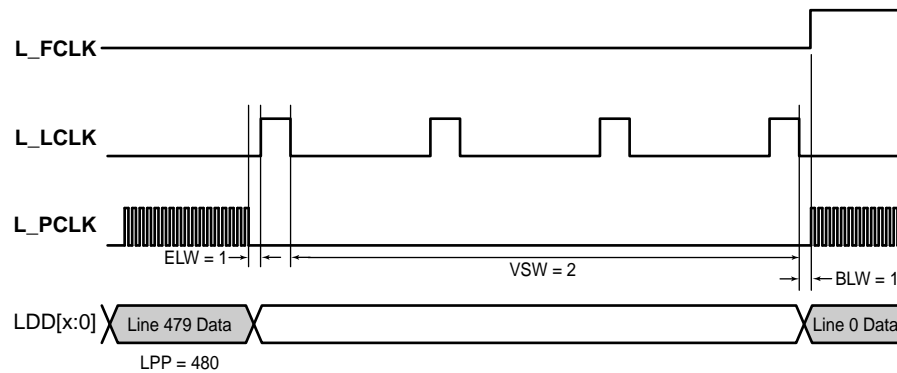
Figure 11-11. Passive Mode End of Frame Timing

Also, changed the Notes: in Figure 11-11 to show the range of BLW as 1 to 256, not 0 to 256. The corrected figure is shown below:

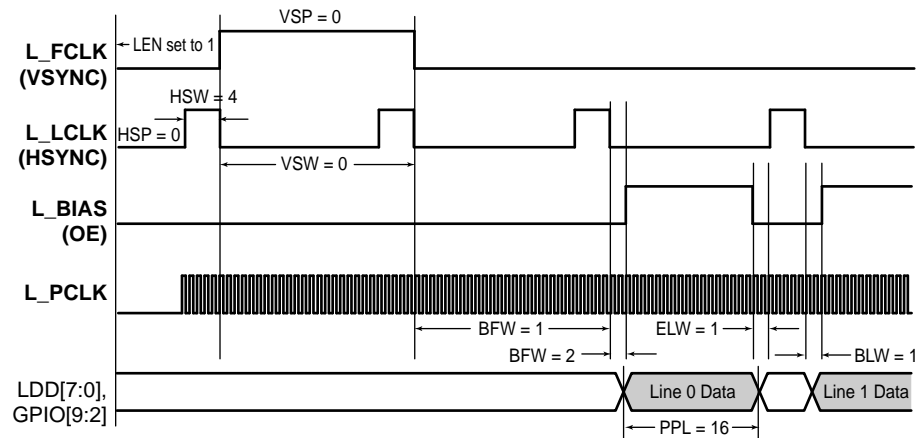
Figure 11-13. Active Mode Timing

Corrected Notes: in Figure 11-13 to show the range of PPL as 16 to 1024 (not 1 to 1024.) The corrected figure is shown below:
