AURIX™ TC37x errata sheet

Marking/Step: (E)ES-AA, AA

10525AERRA

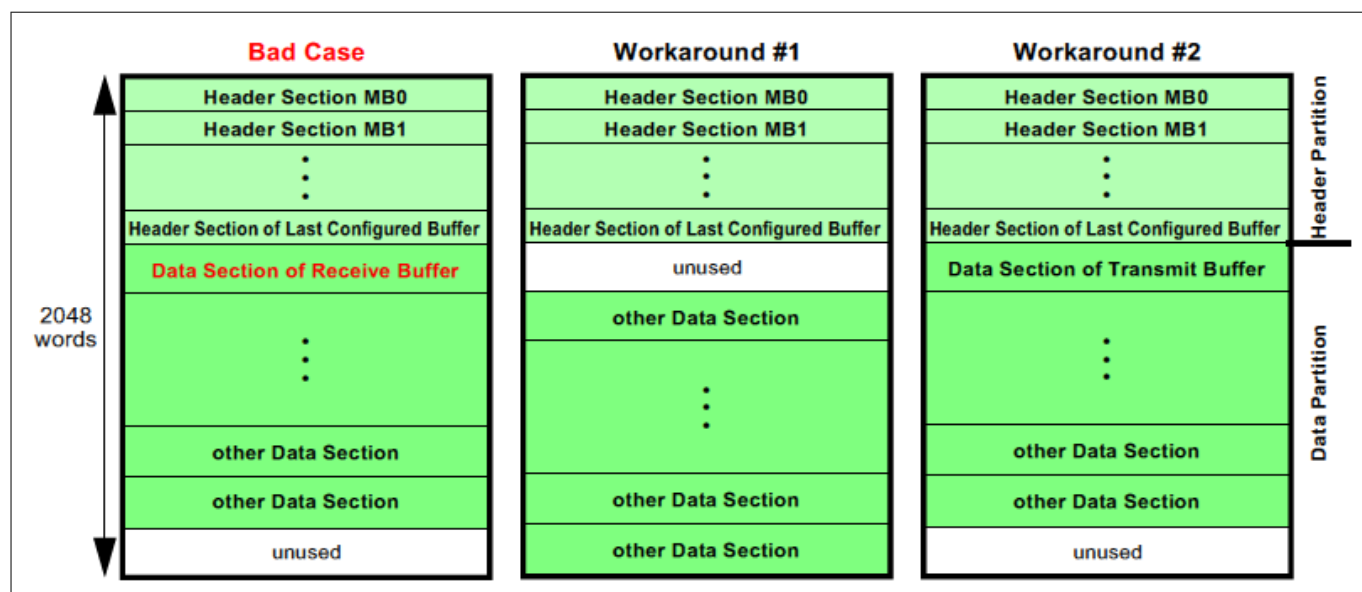
Figure 3 Message RAM configurations

The erratum is limited to the case when (see [Figure 3](#) “Bad Case”):

Ensure that the Data Section directly following the Header Partition is assigned to a transmit buffer.
